From: Rivera, Jose
Sent: Thursday, March 28, 2019 4:22 PM
To: 'sqrgroup sqrgroup'
Cc: 'angelmelendez@jca.gobierno.pr'
Subject: NEW MARITIME TRASNPORATION TERMINAL - TRANSMITTAL OF INSPECTION REPORT
Attachments: NEW MARITIME TRANSPORTATION TERMNAL - INSPECTION REPORT (FEBRUARY 2019 INSPECTION).pdf; NEW MARITIME TRANSPORTATION TERMINAL - TRANSMITTAL OF INSPECTION REPORT TO SQR (FEBRUARY 2019 INSPECTION).pdf

Attached is a copy of the inspection report that EPA issued today. The Report concerns the EPA inspection on February 19, 2019. A copy of the report with cover letter was sent to MTA.

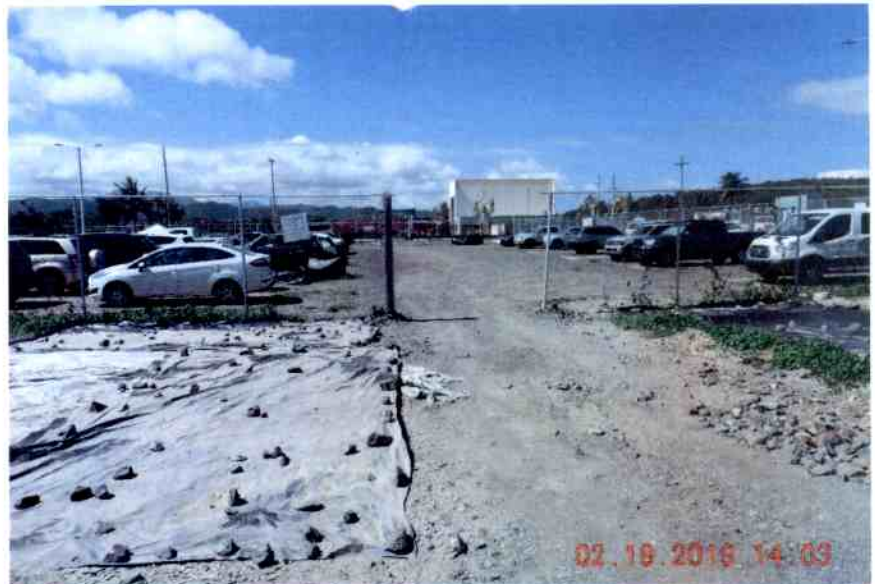
Photo 1 - This photo depicts what has been planned to be the main entrance to the Terminal. The photo depicts areas in need of additional cover for soil stabilization. Dust control measures were not observed.

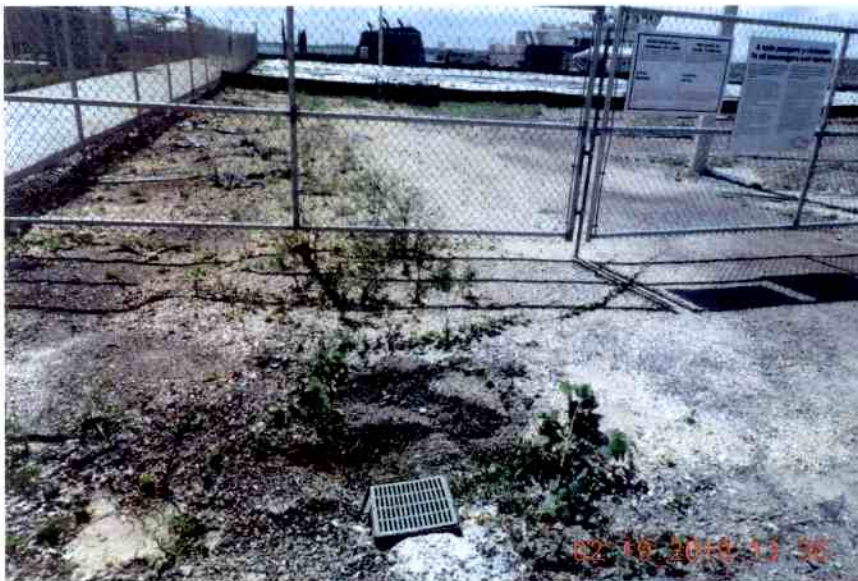
- 5) Two additional catch basins were observed at the Terminal. One of the two catch basin was observed without any inlet protection.⁴ The runoff collected in these two catch basins are conveyed into CB1. CB1 discharges into outfall 001.

Photo 2 - This photo depicts an inlet without inlet protection. This inlet is hydraulically connected to CB1.

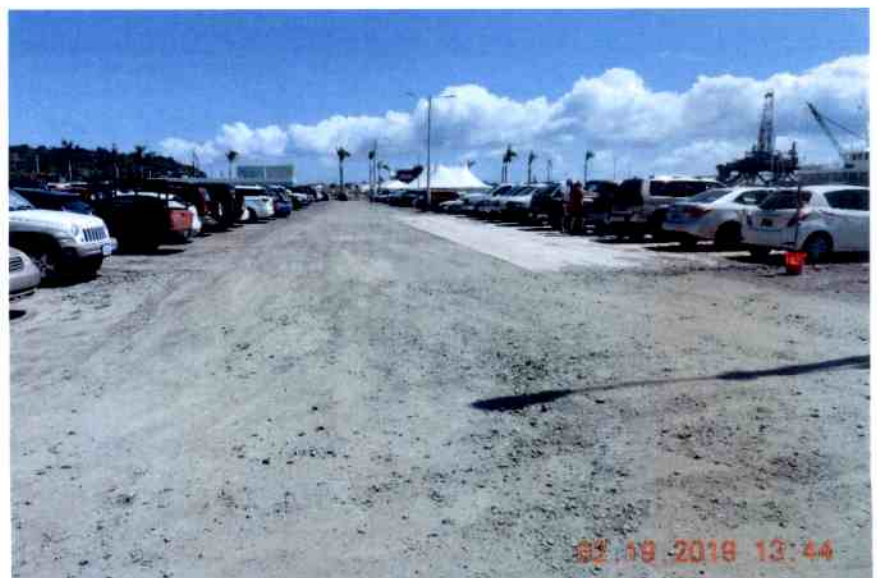
- 1) Dust control practices to unpaved areas of the Terminal were not provided.
- 2) Vehicle traffic in the visitors parking areas are causing dust emissions due to lack of and/or inadequate soil stabilization.
- 3) The EPA Inspector experienced dust emissions caused by wind blows.

Photo 3 - This photo depicts a visitors parking area without adequate soil stabilization and lack of dust controls.

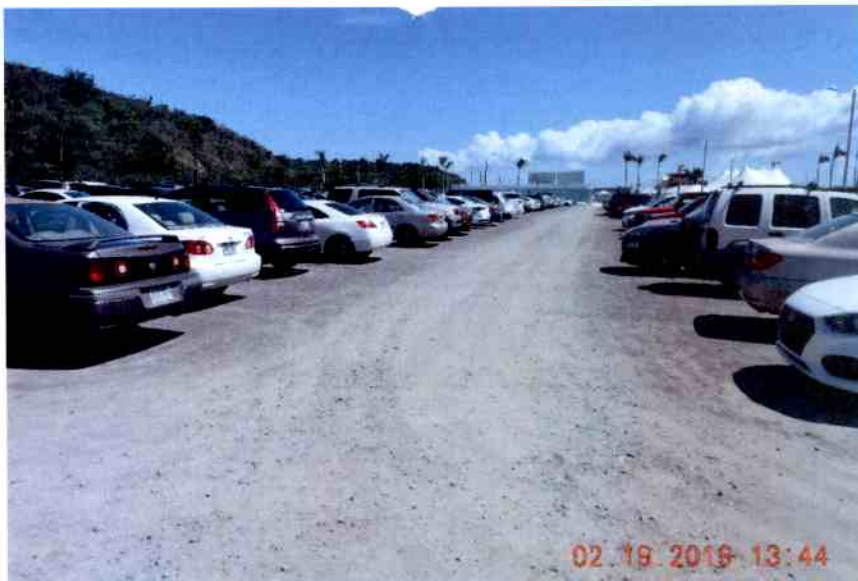
Photo 4 - Another area of the visitors parking area showing same findings described in Photo 3.

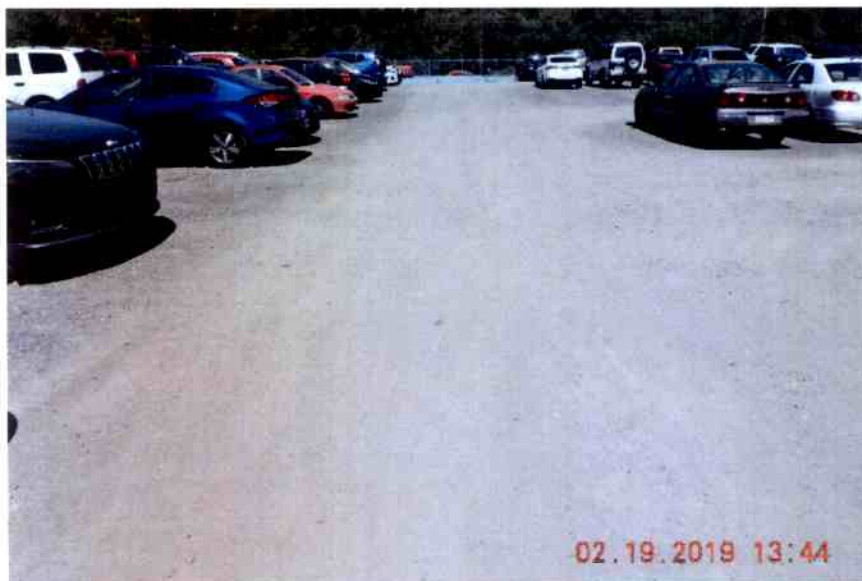
Photo 5 - Another area of the visitors parking area showing same findings described in Photo 3.

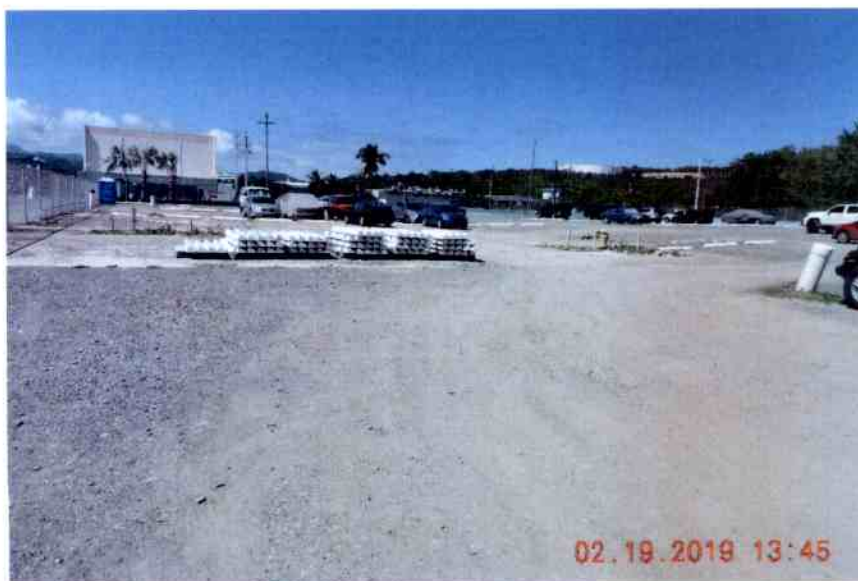
Photo 6 - Another area of the visitors parking area showing same findings described in Photo 3.

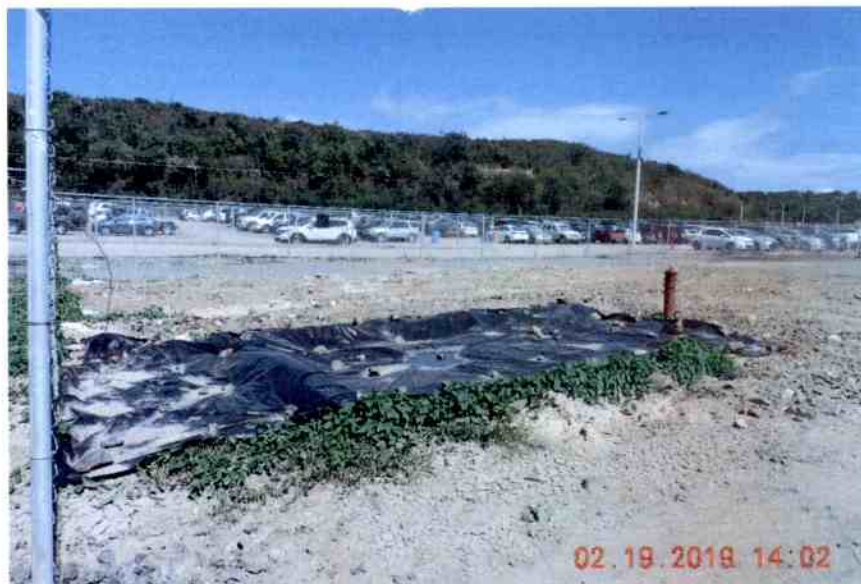
Photo 7 - Area to be completed for temporary cargo parking with plastic cover. Other areas with defficient soil stabilization or no soil stabilization.

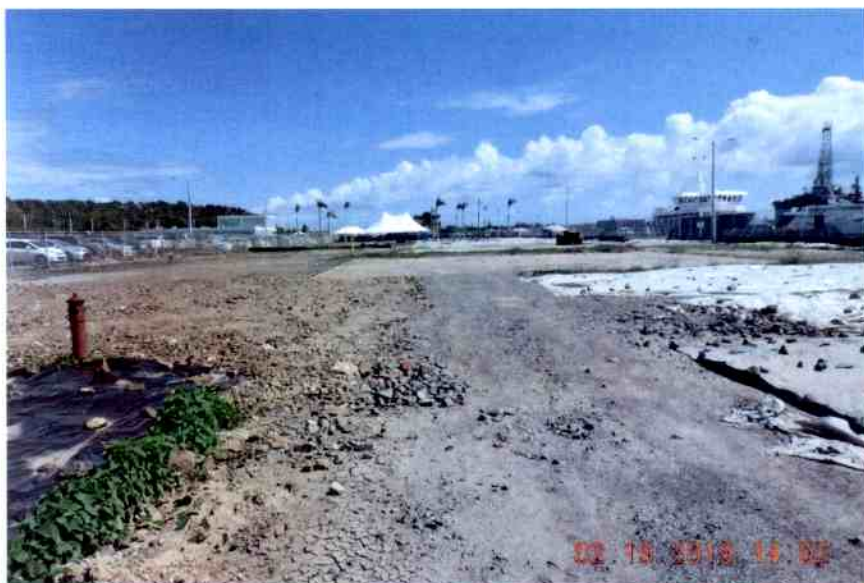
Photo 8 - Another view of Photo 7.

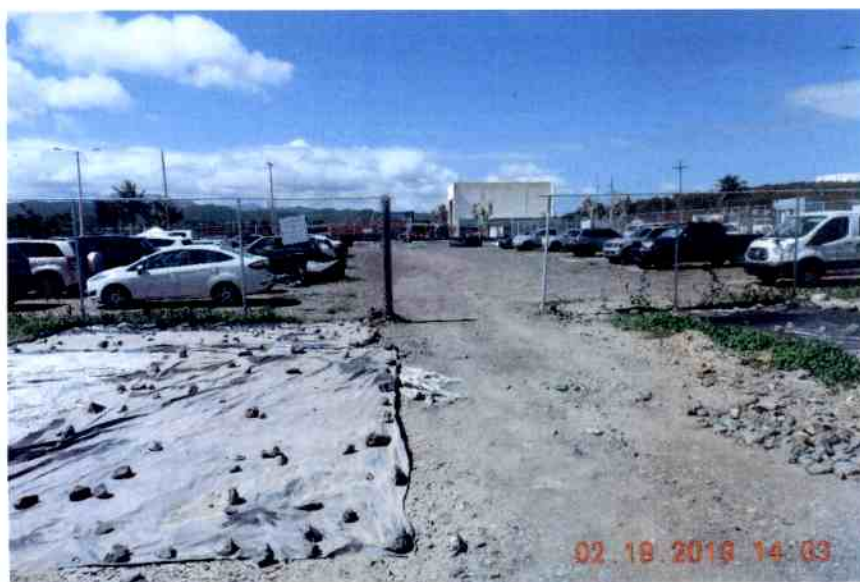
Photo 9 - Areas of the visitors parking lot where heavy traffic takes place. Soil stabilization was inadequate. No implementation of measures for dust control.

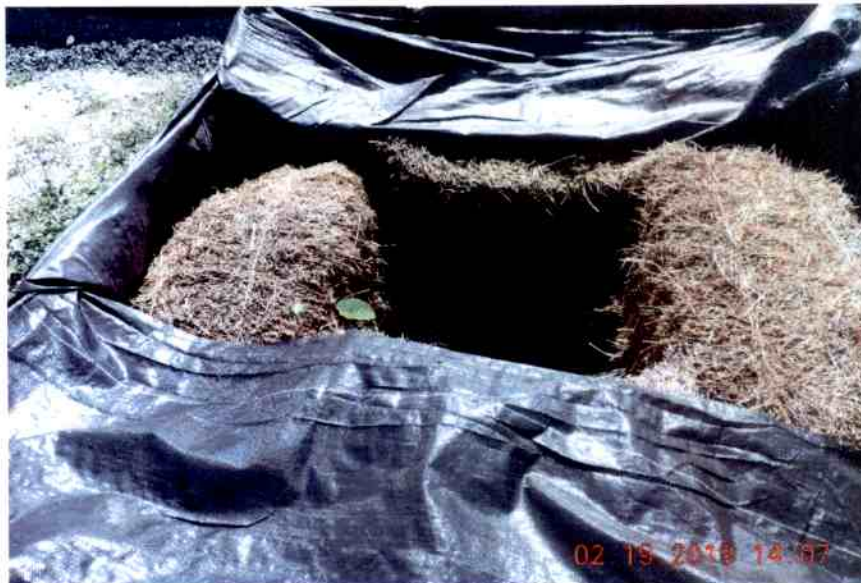
Photo 17 - This photo shows two of three inlets that were not identified in the previous two EPA inspections. The inlet to the left of the photo had final stabilization - sod, and the other one lacked inlet protection. A closer view of the inlet without protection is shown on the next photo. None of these two inlet were included in the site map included in the Stormwater Pollution Prevention Plan developed for the construction of the Terminal.

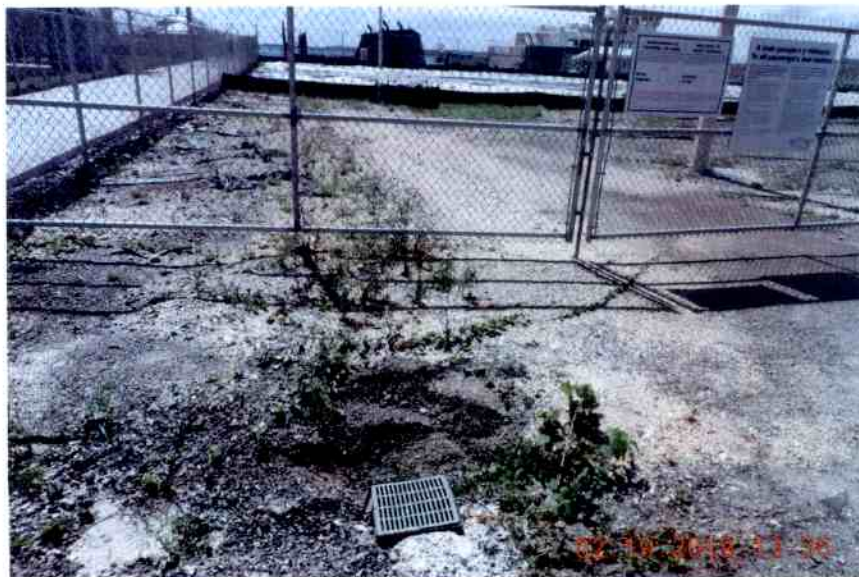
Photo 19 - This inlet is located behind the main Terminal building, but was not identified in the site map included in the Stormwater Pollution Prevention Plan developed for the construction of the Terminal.

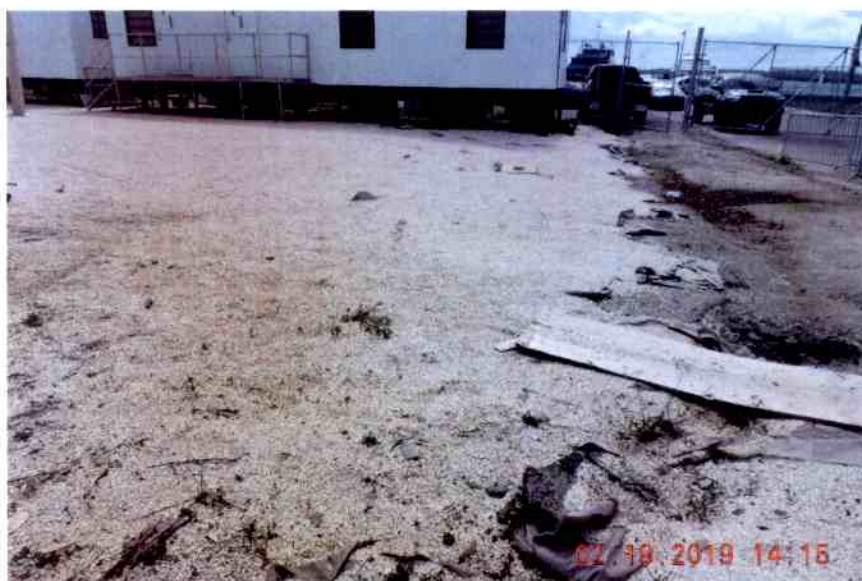
Photo 21 - View of an area of the Terminal neighboring the waterfront in which waste containers were opened to the elements. The photo depicts patches of soil without stabilization and a slit fence installed along the perimeter.

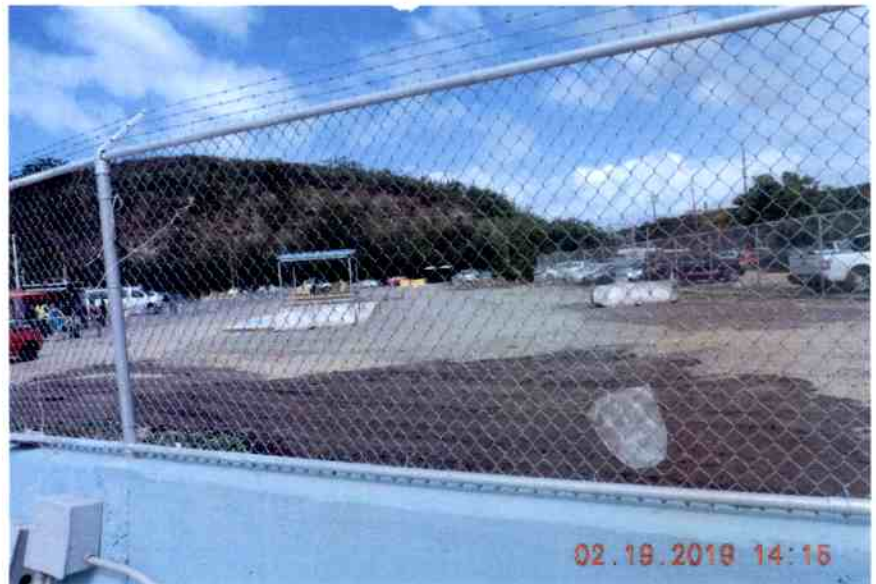
Photo 1 - This photo depicts earth movement activities performed at the adjacent parcel of land. No soil stabilization practices were observed. Other than the installation of a silt fence depicted on the next photo, no erosion controls practices were observed.

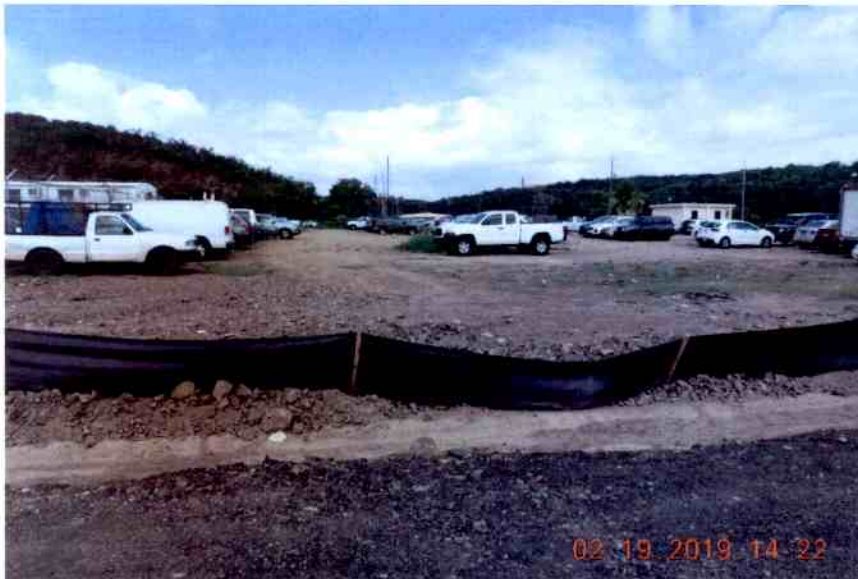
Photo 2 - This is another view of the adjacent parcel of land. A silt fence was installed. The concrete swale collects stormwater runoff from the Terminal and the adjacent parcel of land. This swale conveys stormwater runoff into a storm inlet CB3 depicted in the next photo.

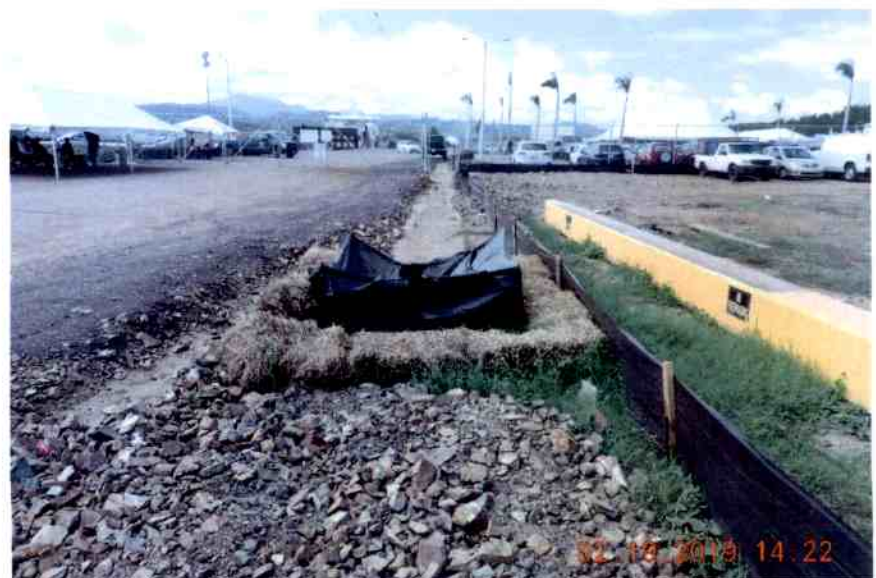
- 3) The Catch Basin #3 (CB3) located near the cargo entrance of the Terminal was provided with inlet protection.
- 4) The silt fence material used for CB1, CB2 and CB3 needs reinstallation and/or replacement because the installation did not follow good engineering practices for erosion controls.

Photo 3 - Another view of the concrete swale and storm inlet CB3. The inlet was provided with hay bales and silt fence protection, and was installed by SQR Architects & Engineers. The photo also depicts the entrance to the Terminal for cargo and employee parking areas.

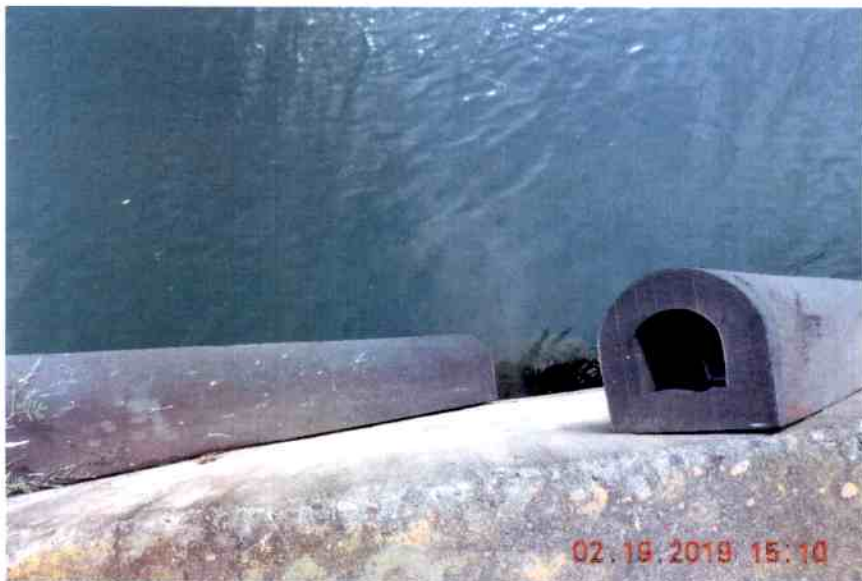
- 6) At approximately 2:57 p.m., the EPA Inspector observed a discharge of the potable water carrying sediments into Ensenada Honda Bay.
 - 7) The discharge had a light brown color and caused a small plume near outfall 003.
- d. Storm Drain Inlet Protection
- 1) CB3 had inlet protection.
 - 2) The CB4 did not have inlet protection.
- e. Dust Controls
- 1) The EPA Inspector did not observe dust control practices at the adjacent parcel of land.
 - 2) The EPA Inspector experienced dust emissions caused by wind blows near the gate for cargo transportation into the Terminal.
- f. Soil Stabilization
- The EPA Inspector did not observe any soil stabilization at the adjacent parcel of land.
- g. Perimeter and Run-on Controls
- The EPA Inspector did not observe any perimeter and run-on controls at the adjacent parcel of land.

Photo 5 - This photo depicts the discharge point / outfall 003 into the Bay. A light brown discoloration plume caused is shown near outfall 003. This resulted from the water test to identify the discharge location into the Bay.

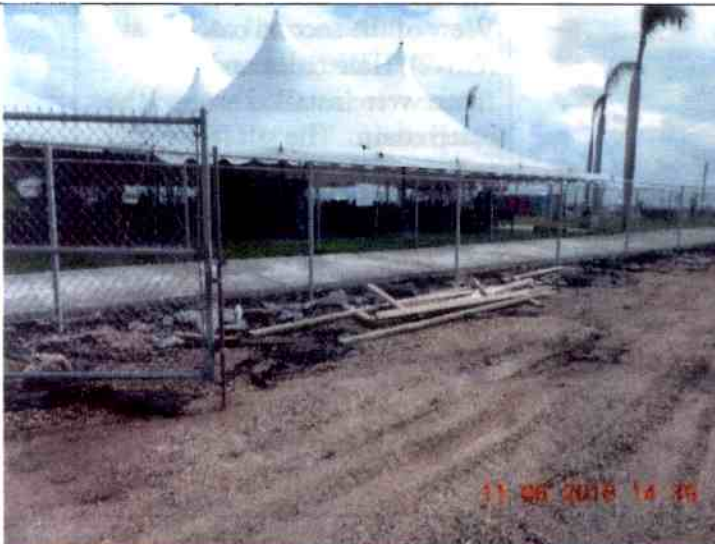
Picture 1
View of the concrete path from the parking lot to the terminal building. Erosion controls, such as silt fence, were not implemented in these areas.

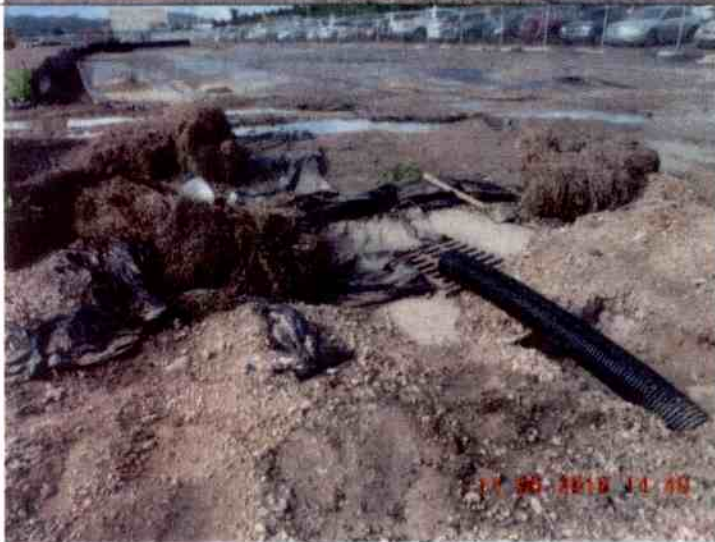
1. **Storage of construction debris** – The EPA Inspectors observed construction debris at the disturbed areas of the Terminal without a dumpster or trash receptacle. Refer to picture 2.

Picture 2
Construction debris were observed placed at the ground surface close to the concrete path to the east side of the waiting area. Picture depicts soils without stabilization.

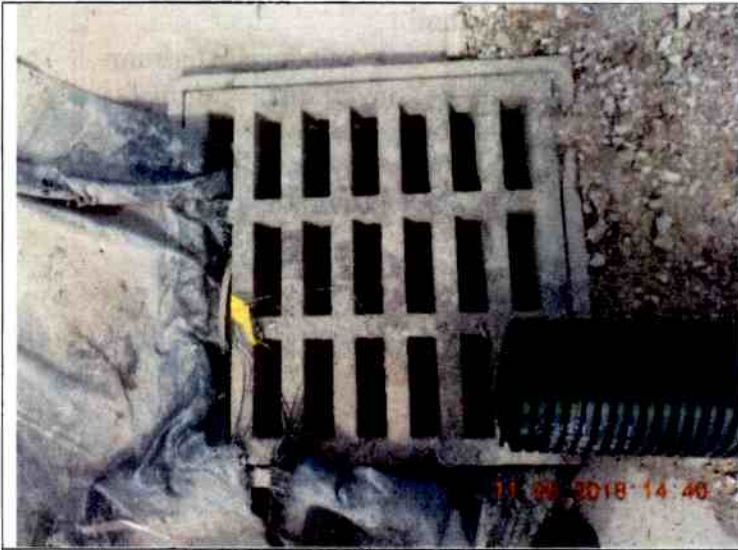
2. **Storm drain inlet protection** – The EPA Inspectors observed the following:
 - a. The Catch Basin #1 (CB1) located closer to the concrete building at the Terminal was unprotected. Refer to Pictures 3 and 4. The bale bales were dispersed and deteriorated, and away from the catch basin. The liner was improperly installed and was not retaining sediments. Sediments were observed at the bottom of the catch basin. Also, a corrugated pipe coming from the east side of the construction site was observed over the catch basin.

Picture 3
View of the unprotected catch basin (CB-1). The bale bales and liner were dispersed around the area and were not protecting the catch basin. Also, a corrugated pipe coming from the east side of the construction site was observed over the catch basin. Picture also depicts loose soil nearby the catch basin.

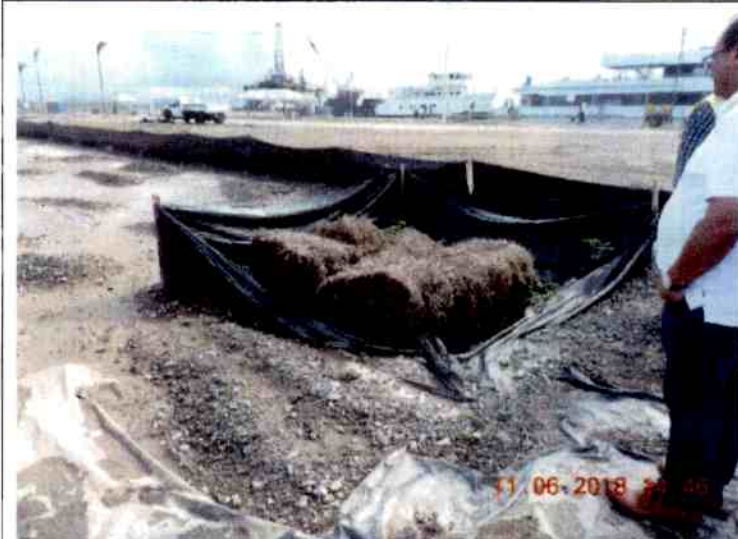
Picture 4
Another view of the unprotected CB-1 from the previous picture. The liner was improperly installed. Sediments were observed at the bottom of the catch basin.

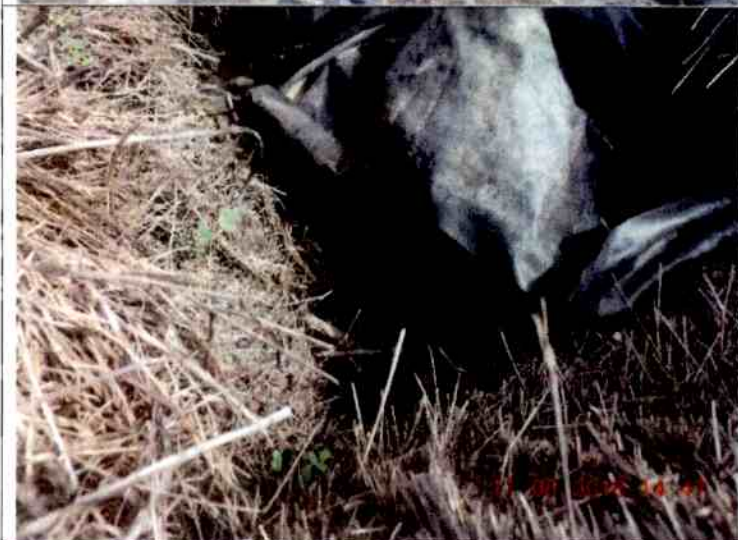
- b. The Catch Basin #2 (CB2) located to the west side of the Terminal had bale bales and silt fence around the catch basin. The liner was improperly installed. The hay bales were deteriorated. Refer to Pictures 5 and 6.

Picture 5
View of the second catch basin (CB-2). Hay bales and silt fence were installed around the catch basin. The silt fence was not properly installed.

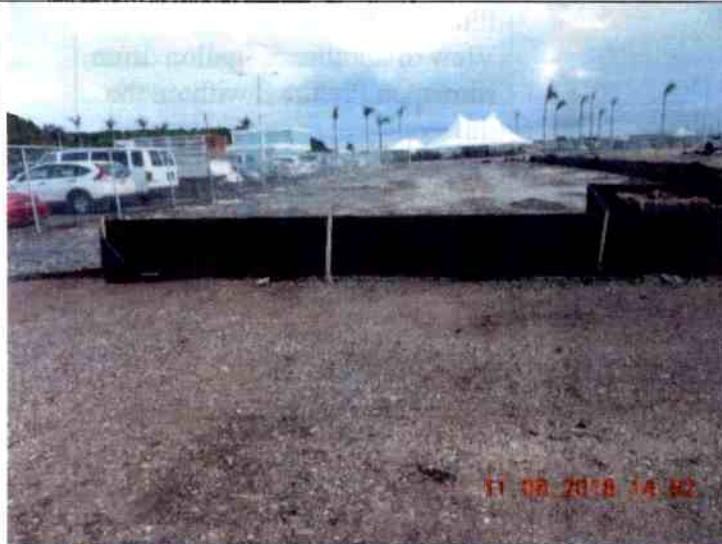
Picture 6
Another view of the CB-2 from the previous picture. The liner was improperly installed.

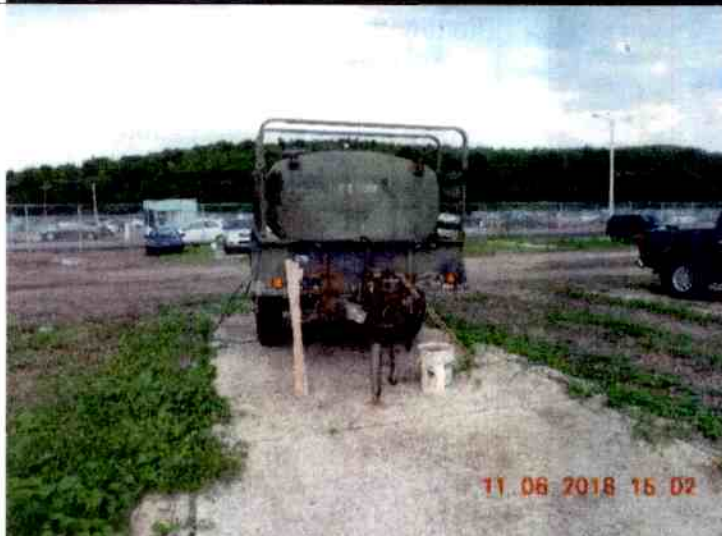
Picture 11
View of the area before the access gate located at the east side of the construction site. Vehicle tracking controls were not installed at the disturbed area prior to entering into the paved road. Tracking of sediments were observed over the road towards the access gate.

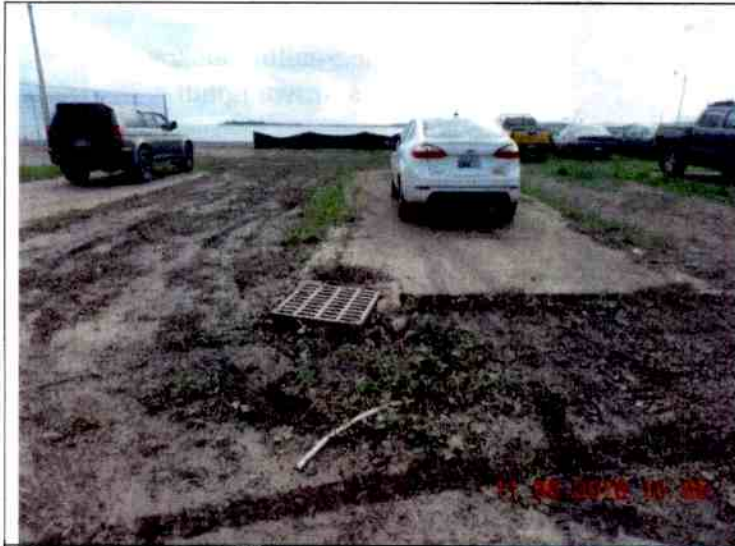
Picture 15
View of the catch basin from
the previous picture. The catch
basin was observed filled with
water of brown color, and exit
pipe could not be observed.

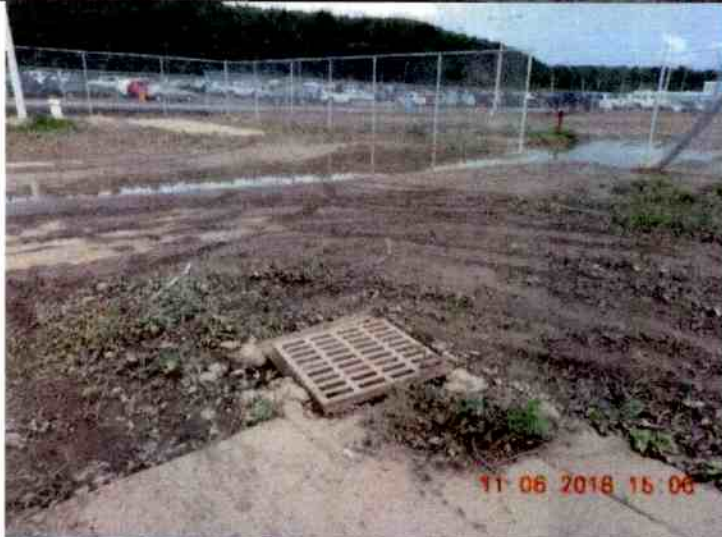
Picture 16
View of an unprotected catch basin at the parking area to the east side of the site. An exit pipe could not be observed.

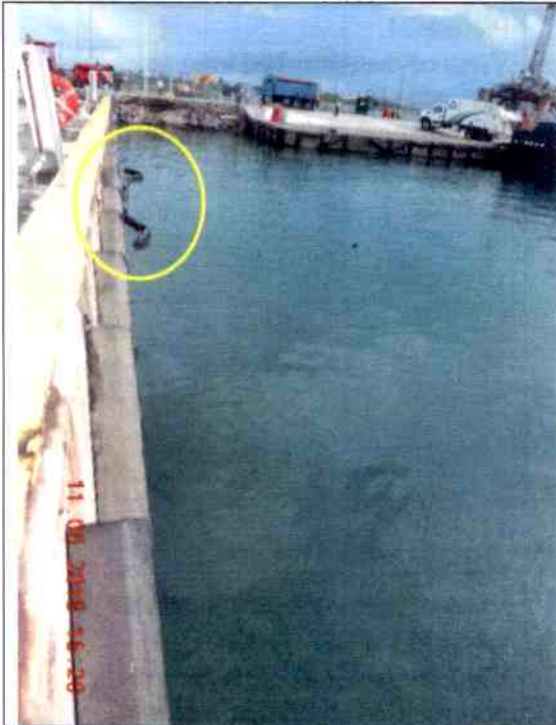
Picture 18
Closer view of Outfall 002 towards the east side of the dock. No turbidity barrier was observed.

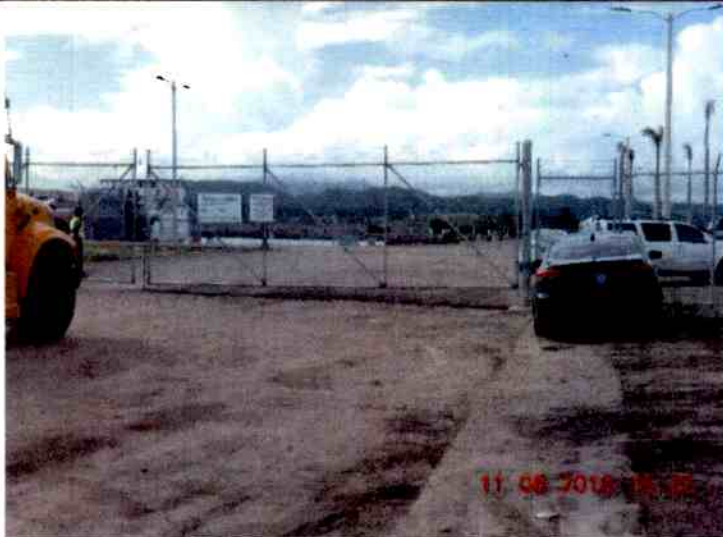
In addition, EPA Inspectors observed clearing activities at the west side of the Terminal building without sediment controls installed. Refer to picture 21.

Picture 21
View of the disturbed area at the west side of the construction site without sediment controls and soil stabilization.

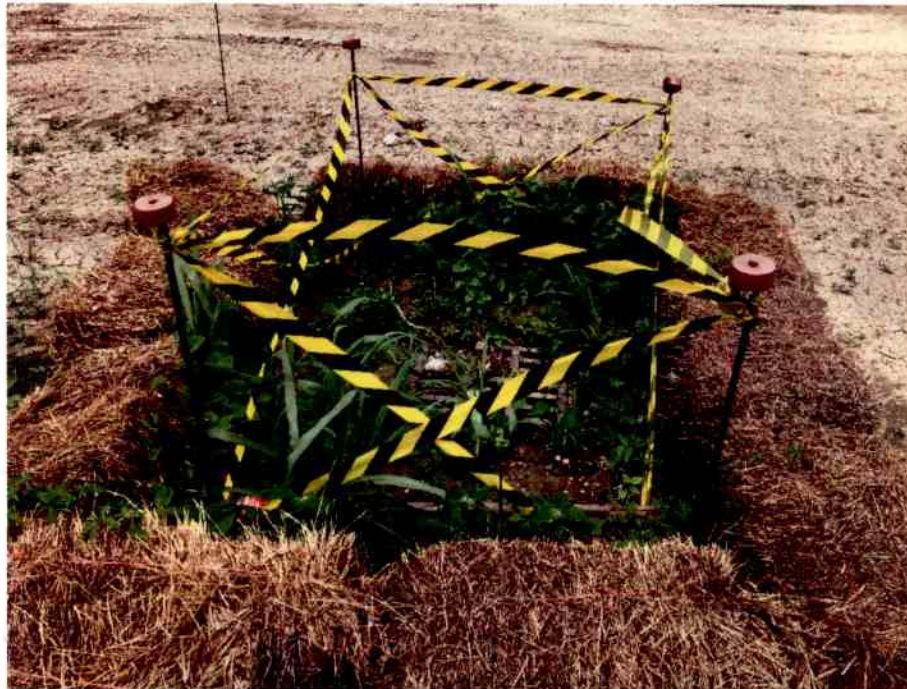
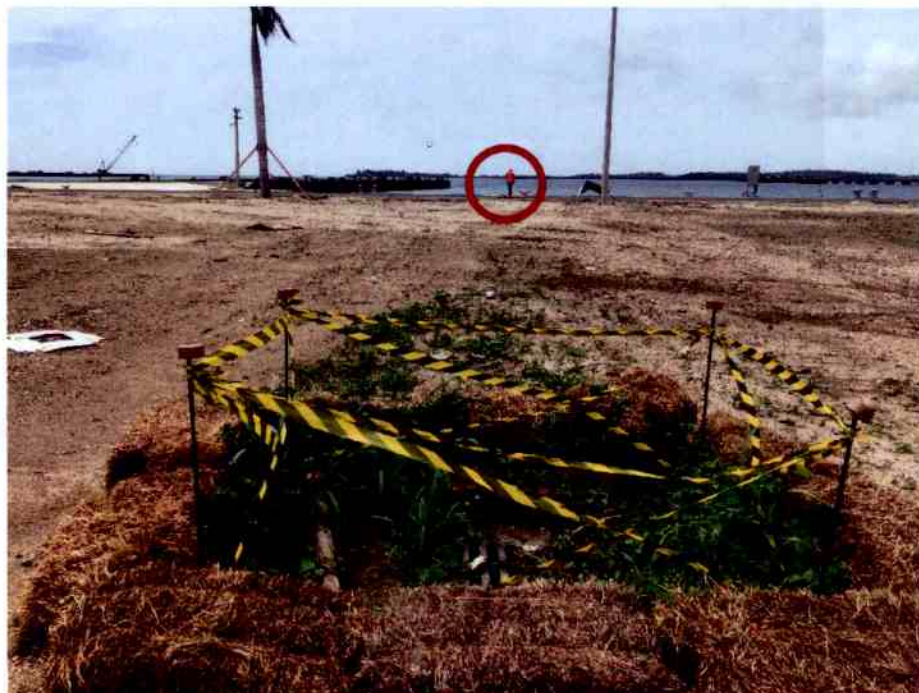
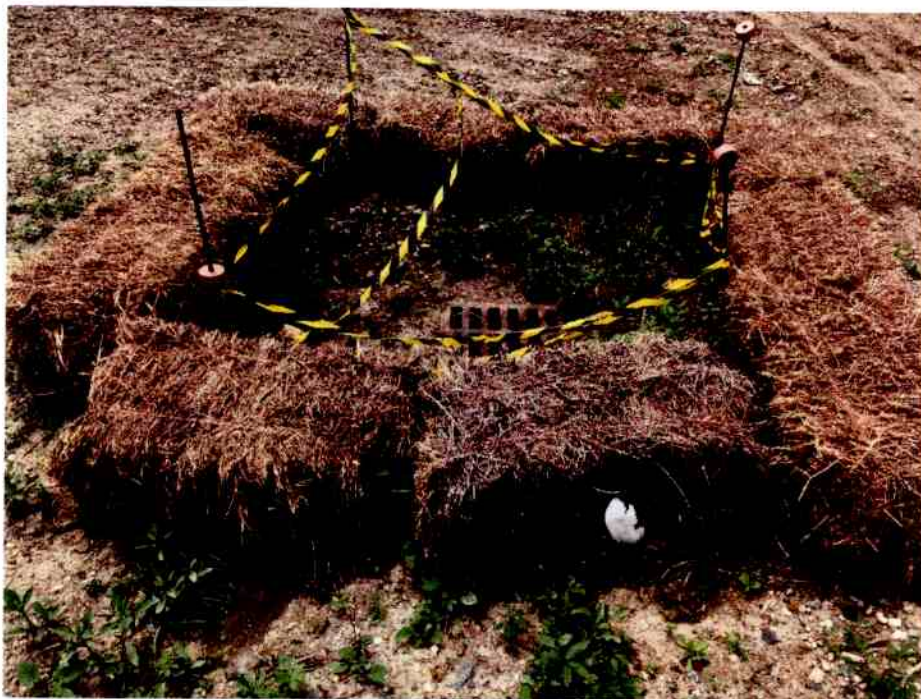
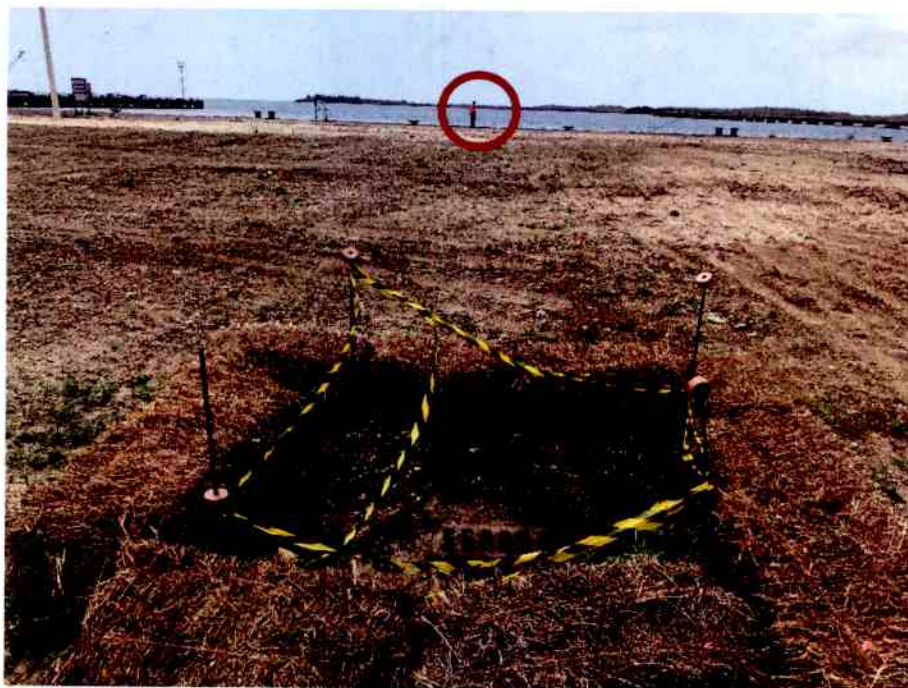
- d. A sign was not observed depicting information about the at the construction project;
- e. As shown on Pictures 1-4, the erosion controls installed to protect CB-1 and CB-2 are deteriorated. Also, the EPA Inspector Rivera observed that both catch basin had debris and sediment accumulation;
- f. Several soil piles were observed without erosion control measures;
- g. The entrance to the Terminal construction areas was observed without off-tracking sediment controls. **Picture 8** depicts one of several soil piles without erosion control measures and the entrance;

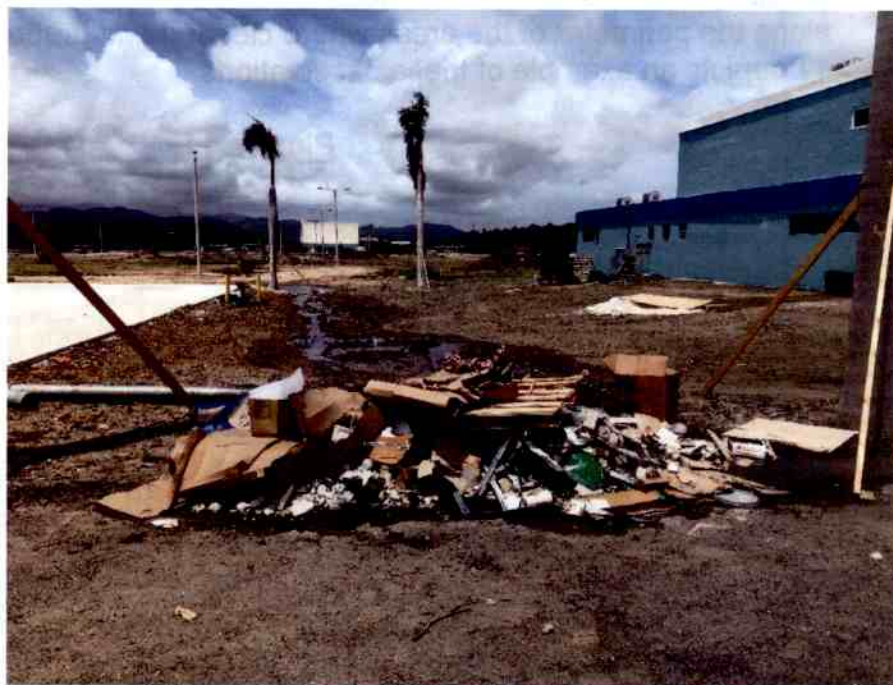
Picture 9

- h. Several waste and debris piles were observed without erosion control measures. **Picture 9** depicts one of several waste and debris piles without erosion control measures.

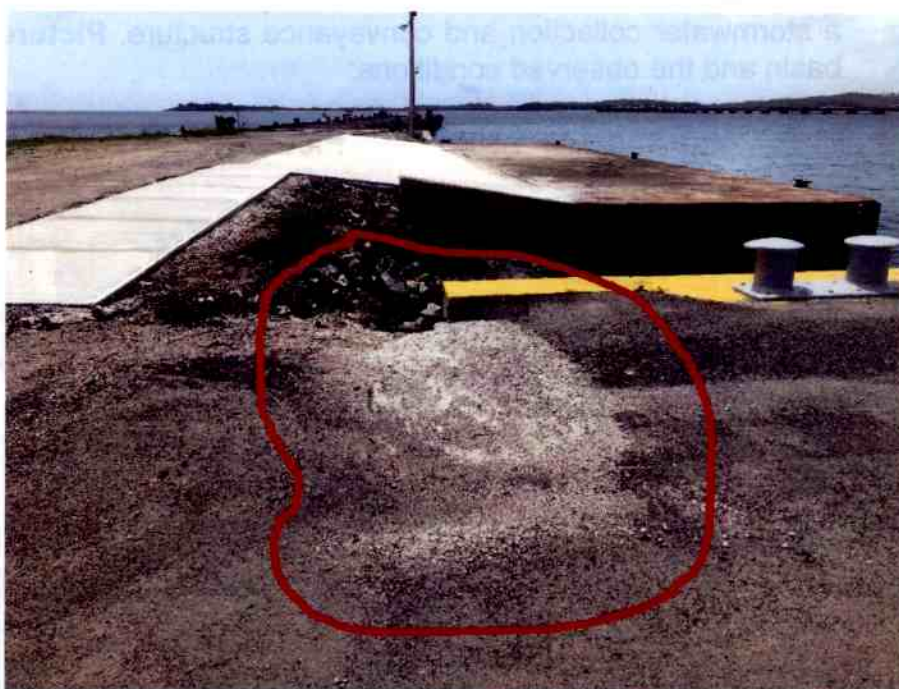
Picture 10

- i. A concrete washout was observed by one of the dock areas. **Picture 10** depicts this observation.

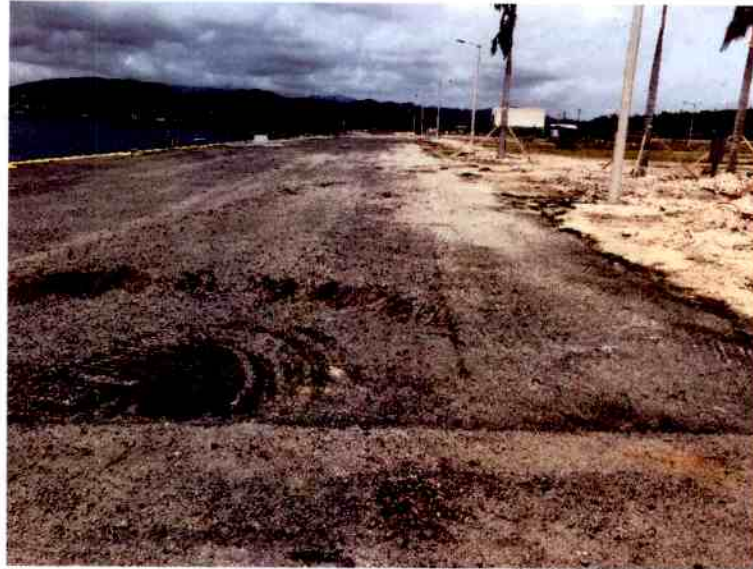
Picture 11

- j. An asphalt-paved road was observed between the areas where clearing and grubbing took place, and the dock area. Sediment controls were not observed along the perimeter of the areas where clearing and grubbing took place. **Picture 11** depicts an example of these observations.

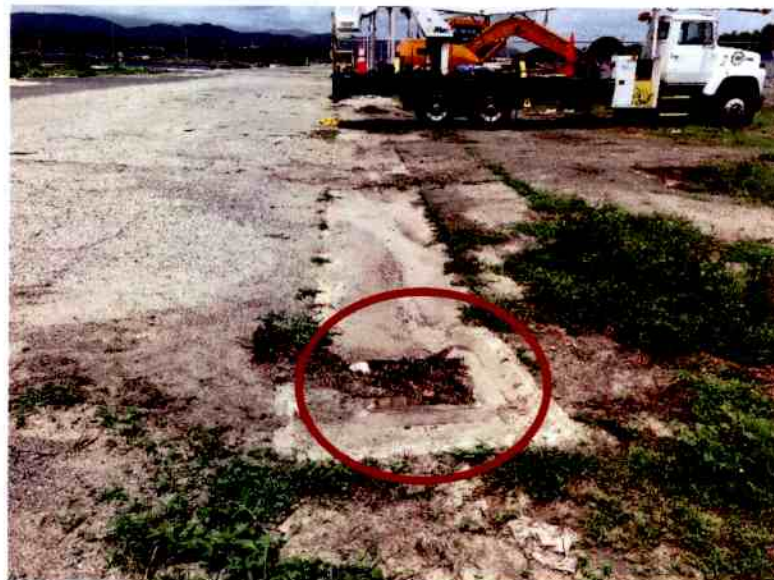
Picture 12

- k. A storm water catch basin was observed without any erosion control and clogged with sediments. This catch basin is located along the asphalt-paved road described immediately above and receives runoff from the southeast areas of the Terminal site. The EPA could not determine the hydraulic connection of this catch basin to a stormwater collection and conveyance structure. **Picture 12** depicts the catch basin and the observed conditions.

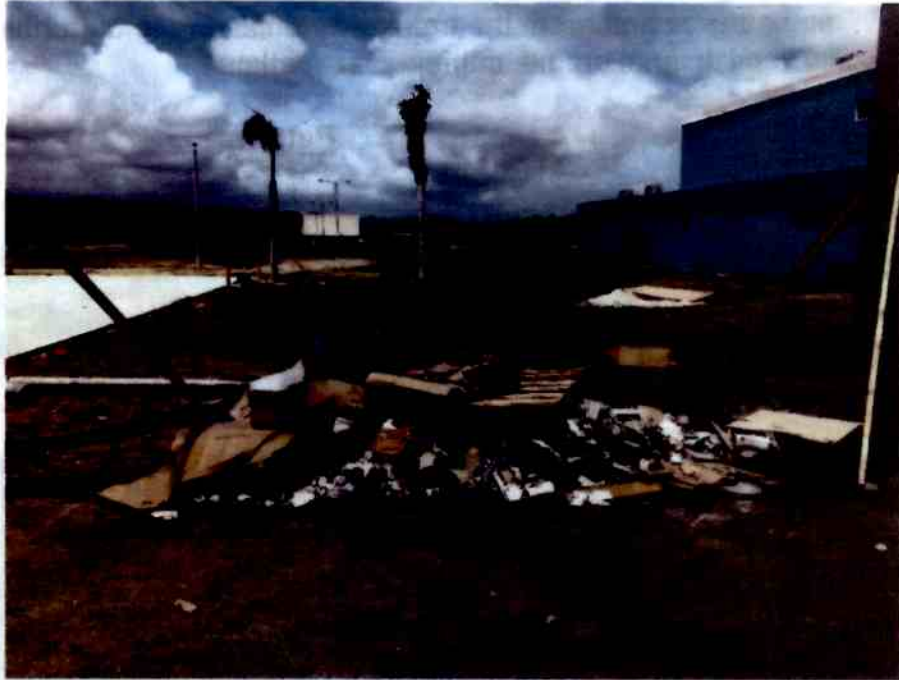
Picture 9

- h. Several waste and debris piles were observed without erosion control measures. **Picture 9** depicts one of several waste and debris piles without erosion control measures.

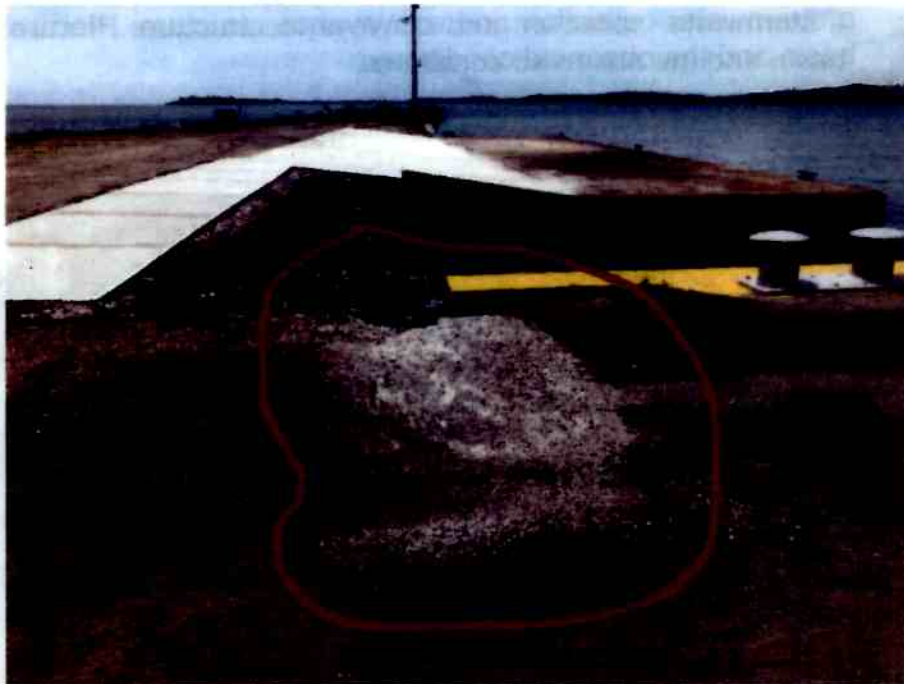
Picture 10

- i. A concrete washout was observed by one of the dock areas. **Picture 10** depicts this observation.

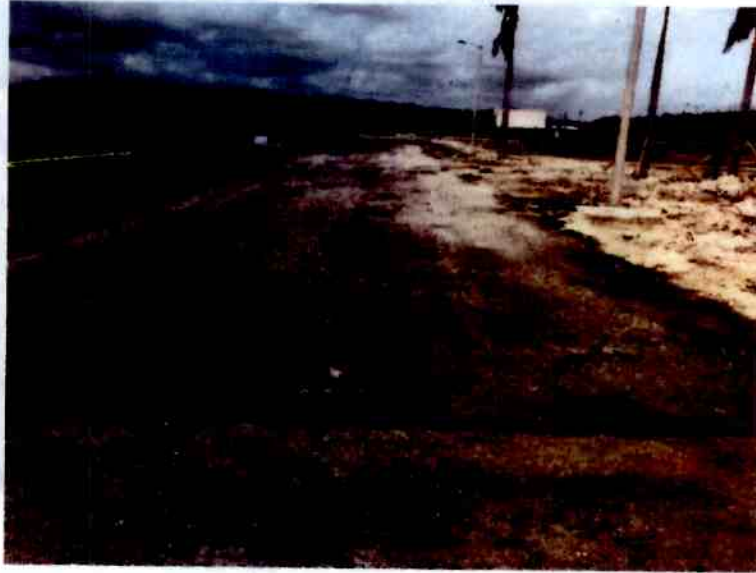
Picture 11

- j. An asphalt-paved road was observed between the areas where clearing and grubbing took place, and the dock area. Sediment controls were not observed along the perimeter of the areas where clearing and grubbing took place. **Picture 11** depicts an example of these observations.

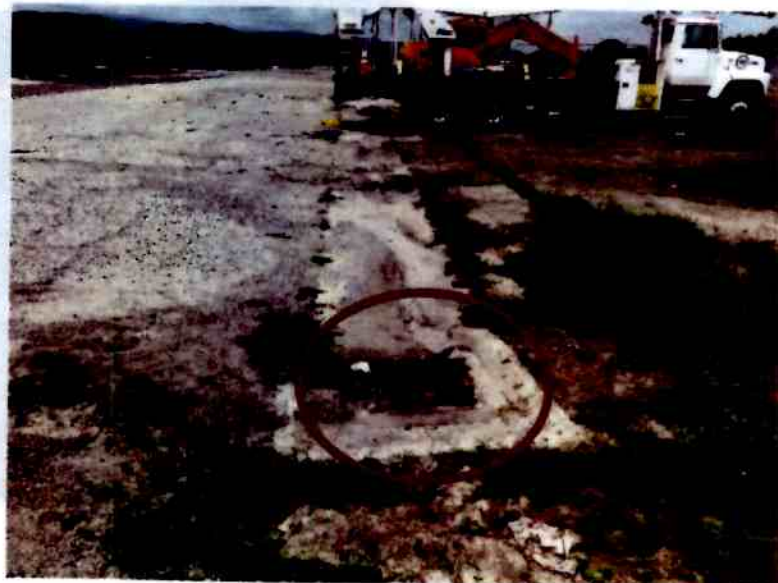
Picture 12

- k. A storm water catch basin was observed without any erosion control and clogged with sediments. This catch basin is located along the asphalt-paved road described immediately above and receives runoff from the southeast areas of the Terminal site. The EPA could not determine the hydraulic connection of this catch basin to a stormwater collection and conveyance structure. **Picture 12** depicts the catch basin and the observed conditions.
